The Splashdam Coal Horizon in Virginia: A Natural, and Active and Abandoned Mine, Hazard¹

Anthony S. Scales²

Abstract. The Splashdam Coal Horizon outcrops principally in Buchanan and Dickenson Counties, Virginia, and is a potential geological hazard in its unmined state. Geological characteristics and topographic location make it a prime source of rockfall, landslide and drainage problems. Abandoned Splashdam surface mines are not typically problem areas, as mining removes potential slide material. Abandoned underground mining, however, has great potential to promote slope failure and cause blowouts due to the Splashdam Horizon's hydrologic and geomorphologic setting. Residential expansion has placed many home sites at risk of impact from the Splashdam Horizon, both in mined and unmined settings. The Abandoned Mine Land Program's long history of addressing these problems has served to provide the Regulatory Program with guidelines to assess proposed mining in this seam. Recognition of the geomorphologic and hydrologic setting of the Splashdam Horizon is critical in remediation design and future mine planning.

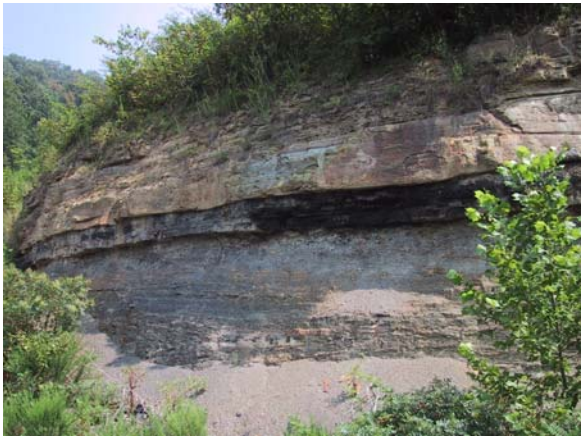
Figure 5. Splashdam seam in highwall, here underlain by shale. Photograph by Gary Shifflett. Buchanan County, Virginia.

The Splashdam Horizon, as noted by Giles previously, typically overlies a thick (average 75 feet, up to 130 feet) cliff and ledge forming sandstone, which in turn overlies the Lower Banner coal bed (see Figure 4). The immediate floor rock can be either shale or this sandstone (see Figure 5). The Splashdam can occur in up to 4 splits separated by highly variable thicknesses of shale and sandstone, but for purposes of this paper we are concerned with those areas where the splits coalesce to form a single underground-mineable seam, or a split is thick enough to be recovered by underground mining. Overlying the Splashdam is a sandstone, identical to the one below seam, or a shale (see Figure 6). This interval averages 100 feet, but can be up to 130 feet to the next higher seam, the Hagy.

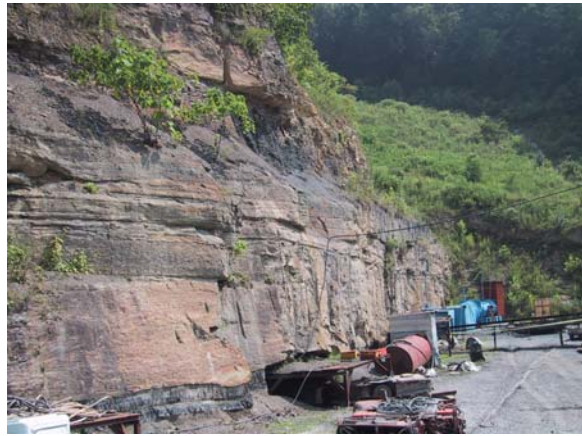
Figure 6. Underground mine face-up with the massive sandstone typically overlying the Splashdam seam. Photograph by Gary Shifflett. Buchanan County, Virginia.

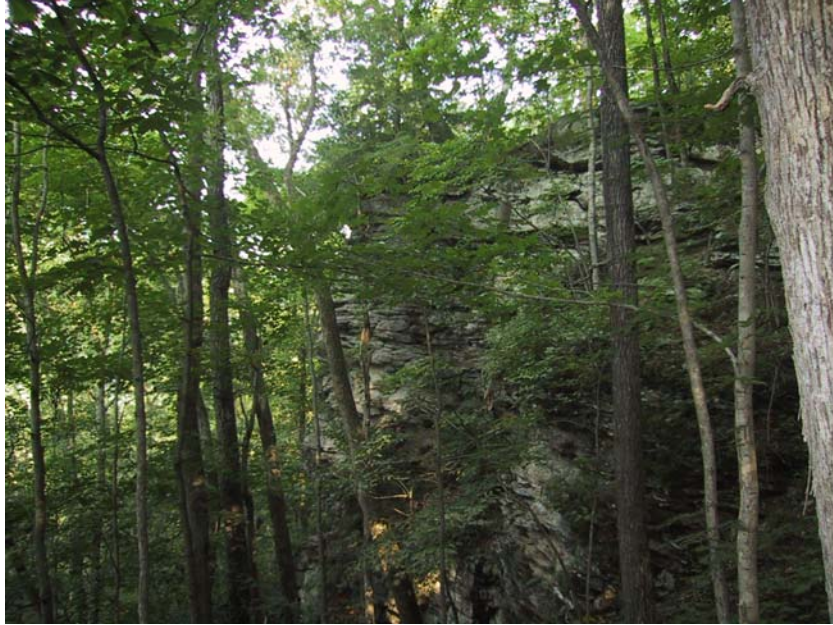
Figure 8. Sandstone cliff at the Splashdam Horizon. Photograph by Gary Shifflett. Buchanan County, Virginia.

In natural (undisturbed) setting, the Splashdam is rarely exposed, but its position can often be estimated by the top of the underlying, ledge-forming sandstone (see Figure 8). Often the seam is covered by sandstone cobbles/boulders, or a sandy-clayey colluvium from the overlying sandstone, and often the colluvium from these two sandstones coalesce to form a cobble slope and/or cobble apron ringing the valley walls (see Figures 9 and 10). In hollows, whether shallow or deep, cragdingles, as defined by Outerbridge (1987), may form. These are upland hollows where sandstone cobbles, often in this sandy-clayey matrix, collect by toppling or eroding from the cliff-forming sandstone. Such deposits are sources for debris flows and landslides.

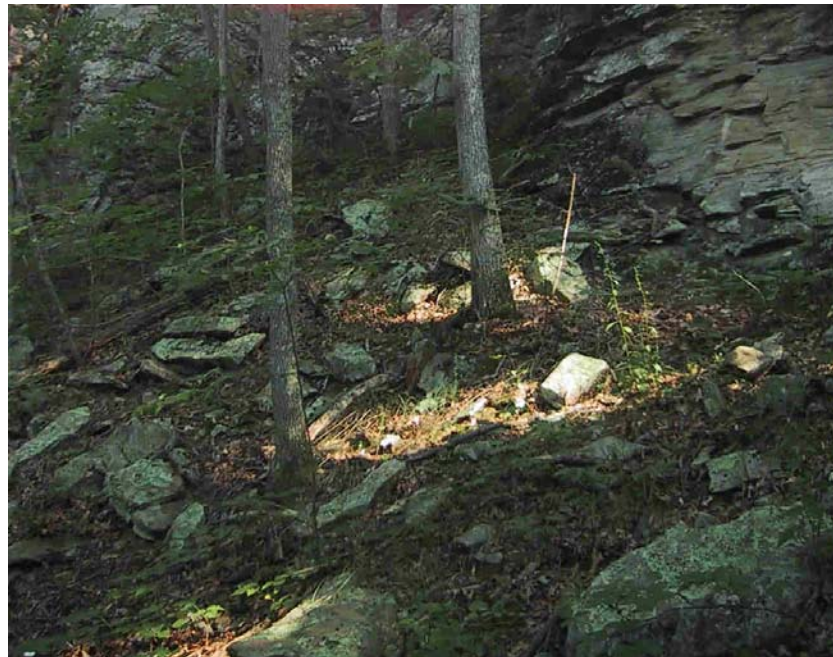
Figure 9. Cobble and boulder apron below sandstone cliff seen in previous figure. Photograph by Gary Shifflett. Buchanan County, Virginia.

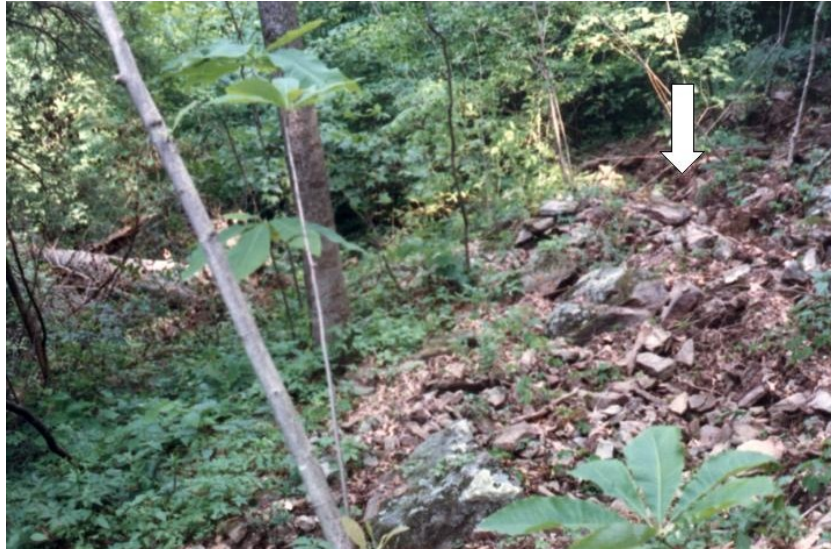
Figure 10. A typical cobble slope at the Splashdam Horizon. The arrow points to a landslide headscarp with approximately 1 foot of vertical displacement. Buchanan County, Virginia.

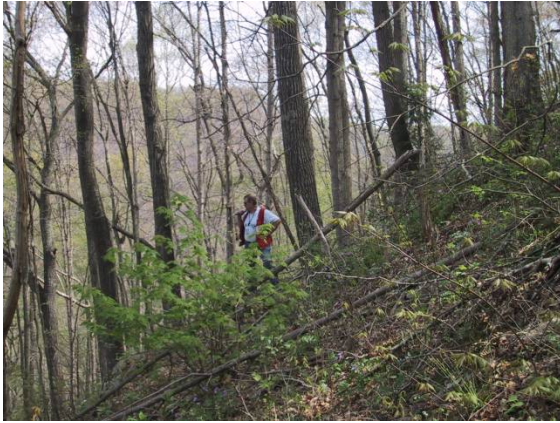
Figure 10. A view of a Splashdam Horizon slope, illustrating steepness. Note the curved tree trunks indicating the slope is continually creeping. Viewpoint is the same as following figure. Photograph by Gary Shifflett. Buchanan County, Virginia.

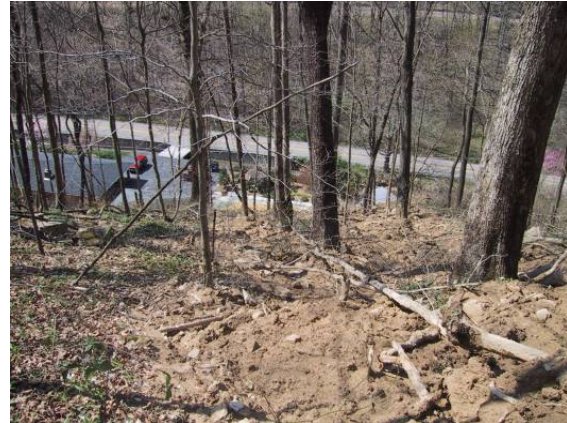
Figure 11. Looking downslope from same viewpoint as previous figure. Splashdam colluvium failed during a high precipitation event, causing the debris and mud flow visible. Photograph by Gary Shifflett. Buchanan County, Virginia.

While it is more proper to define the hazard potential of the Splashdam seam in terms of its encapsulating rocks, and the weathering products of the seam and those rocks. i.e. the “horizon,” the Splashdam itself plays a key role due to its transmissivity. The weathered encapsulating shales and sandstones, whether in the form of a colluvial apron, cobble slope or crag dingle, are often in a constantly lubricated state where the Splashdam discharges water. These slopes are often at near-angle of repose, 30 degrees or higher (see Figure 10). Scales (1995) noted that, during high precipitation events, excess water, whether from upslope runoff or from the seam itself, can mobilize the weathered colluvium, causing slumps, debris avalanches, debris flows and landslides (see Figures 11, 12 and 13).

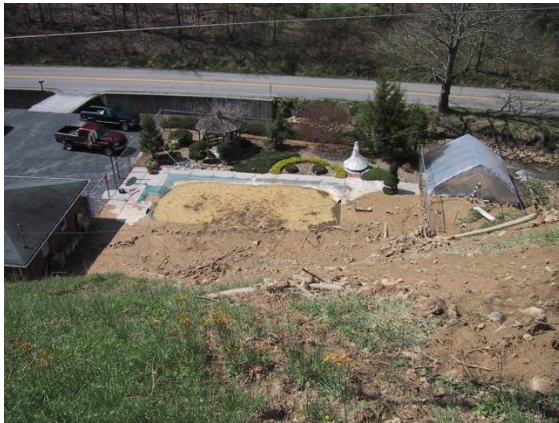
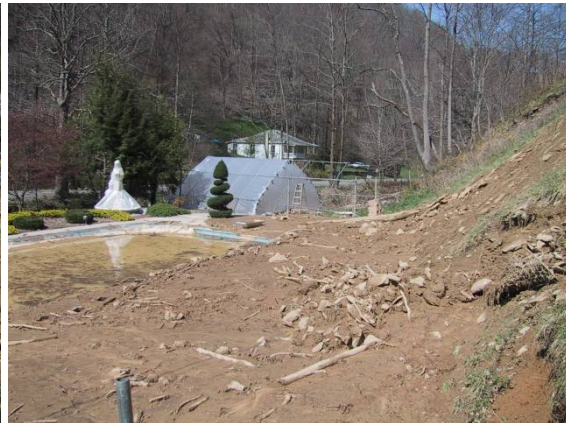
Figures 12 and 13. Newer home sites in the Southwest Virginia Coalfield, if not on mountaintop, are built along valley bottoms. Where below the Splashdam Horizon, situations such as this may occur. Debris and mudflow is from area shown in previous two figures. No abandoned or active mining was involved in its formation. Photographs by Gary Shifflett. Buchanan County, Virginia.

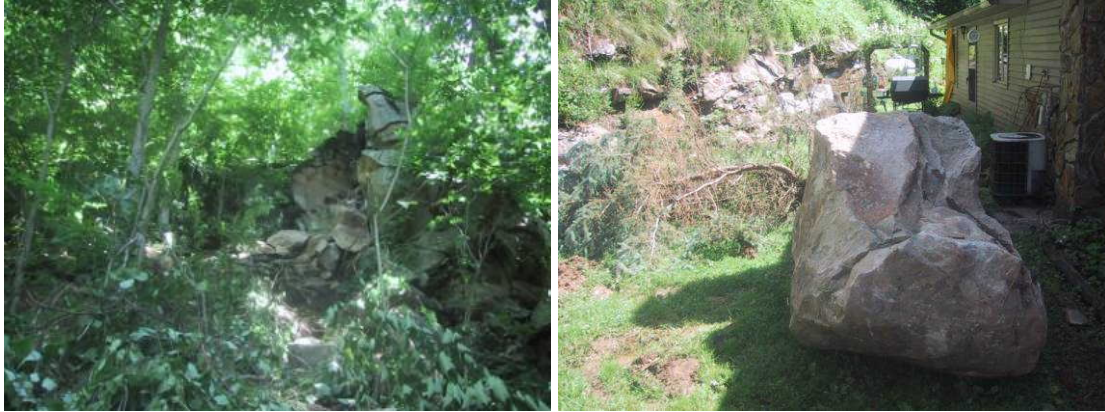
Figures 14 and 15. Left photograph shows the source cliff for the boulder seen in right photograph. No abandoned or active mining was involved in this occurrence. Cliff is 600 horizontal feet away from, and 200 vertical feet above, the residence. Two smaller boulders entered the home; no one was injured. Buchanan County, Virginia.

Where the Splashdam seam exists in a cliff or ledge setting, rockfall potential is high (see Figures 14 and 15). Rockfalls may be initiated by any event, from high precipitation to long-term weathering. (Note: All surface mines are required to have in place a ground control plan to prevent such occurrences, but is of special concern at the Splashdam Horizon).

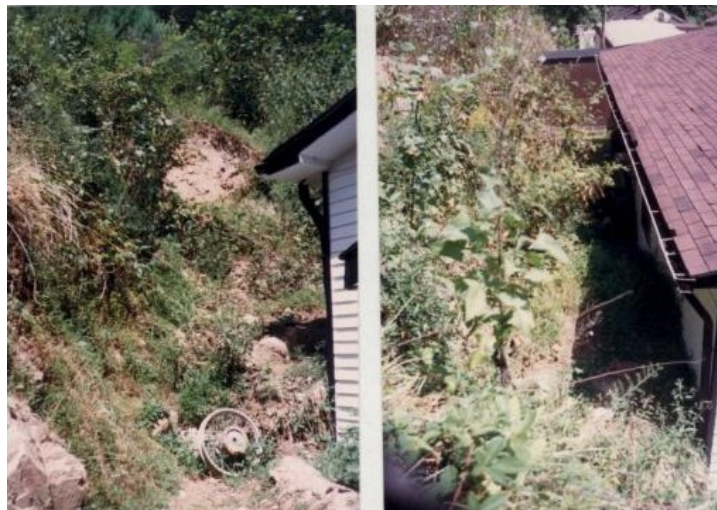
Figures 16 and 17. A poorly sited house; excavation did not encounter bedrock and undercut the already unstable Splashdam colluvial slope. The ground crept for years, finally slumping during high-intensity rainfall. No mining was associated with this occurrence. Buchanan County, Virginia.

As with any geo-hazard, its potential to cause harm or damage must be gauged by man's interaction, or potential to interact, with it. In the 18th and 19th centuries, home site construction in the coalfield area occurred along valley bottom or on ridgetops, i.e., the top of the plateau. Early settlers picked choice spots, and obviously did not choose to build on unstable ground or below ledges and cliffs. However, beginning in the 20th century and continuing to present, with choice sites occupied and coalfield population increasing, new home sites and other construction have expanded into these less desirable, if not downright dangerous areas, including the midslope of valleys where the Splashdam occurs (see Figures 16 and 17).

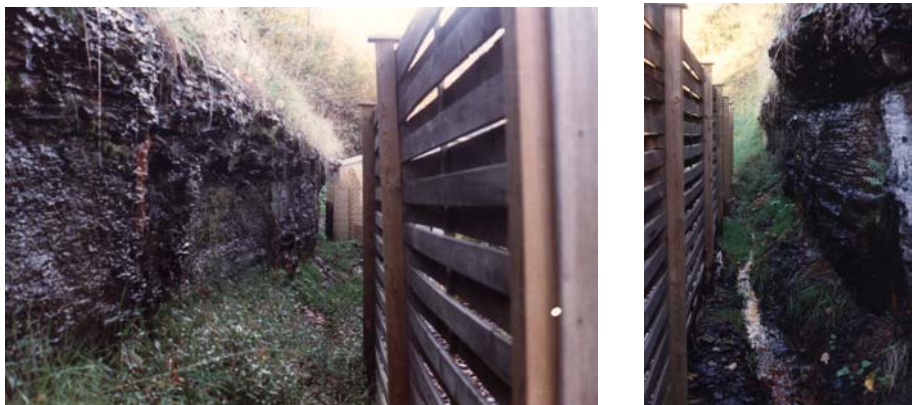
Figures 18 and 19. These photographs show good house seat construction along a valley slope; excavation was into bedrock. Unfortunately, an underground Splashdam mine in the slope above served as a groundwater collection gallery, water bleeding through the outcrop barrier and over the cut slope; the water is highly ferruginous, but not acidic. Buchanan County, Virginia.

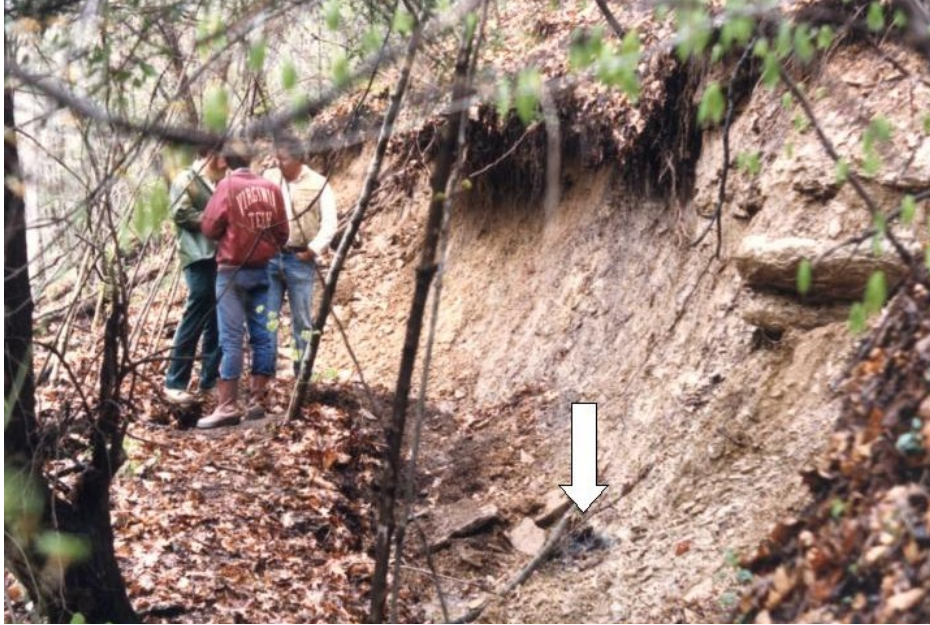
Figure 20. Landslide headscarp resulting from a blowout. The top of a Splashdam split is indicated by the arrow; a middleman separates this unmined split from the mined split. Water exited from fractures in the sandstone well above the mined seam, initiating the slide higher than the mine horizon. Buchanan County, Virginia.

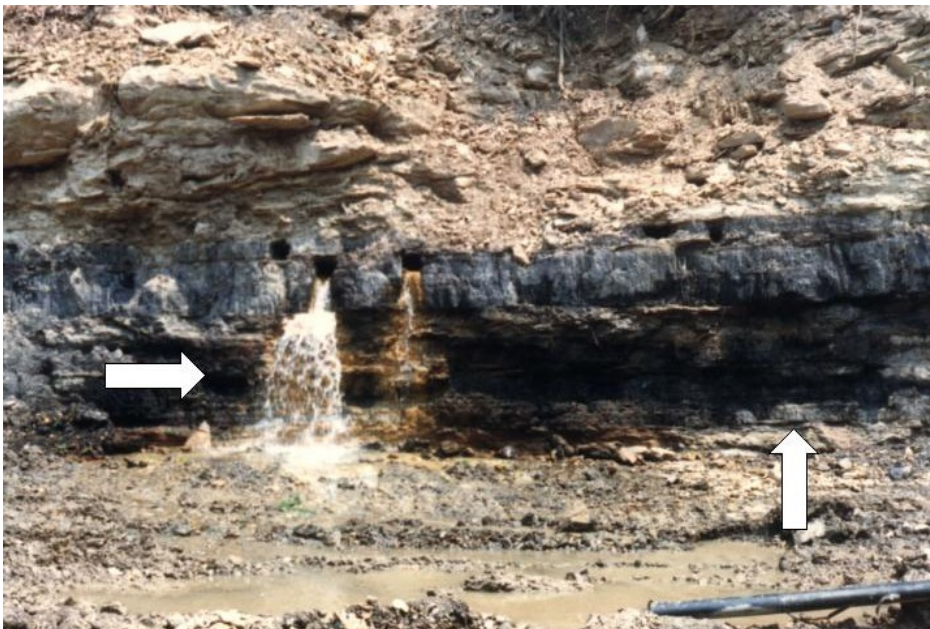
Figure 21. Horizontal drilling, shown here, drained the mine that caused the landslide in the previous figure. Water is exiting at the unmined split level; drilling started at the unmined split, penetrated the middleman (horizontal arrow) and entered the mined split (vertical arrow) at depth. Buchanan County, Virginia.
